**Report on the Explosion, Fire, and
Oil Spill Resulting in One Fatality
and Injury on September 21, 1978,
at Well 6 of Cavern 6 at the West Hackberry,
Louisiana, Oil Storage Site of the Strategic
Petroleum Reserve**

November 1978

U.S. Department of Energy
Washington, D.C. 20545

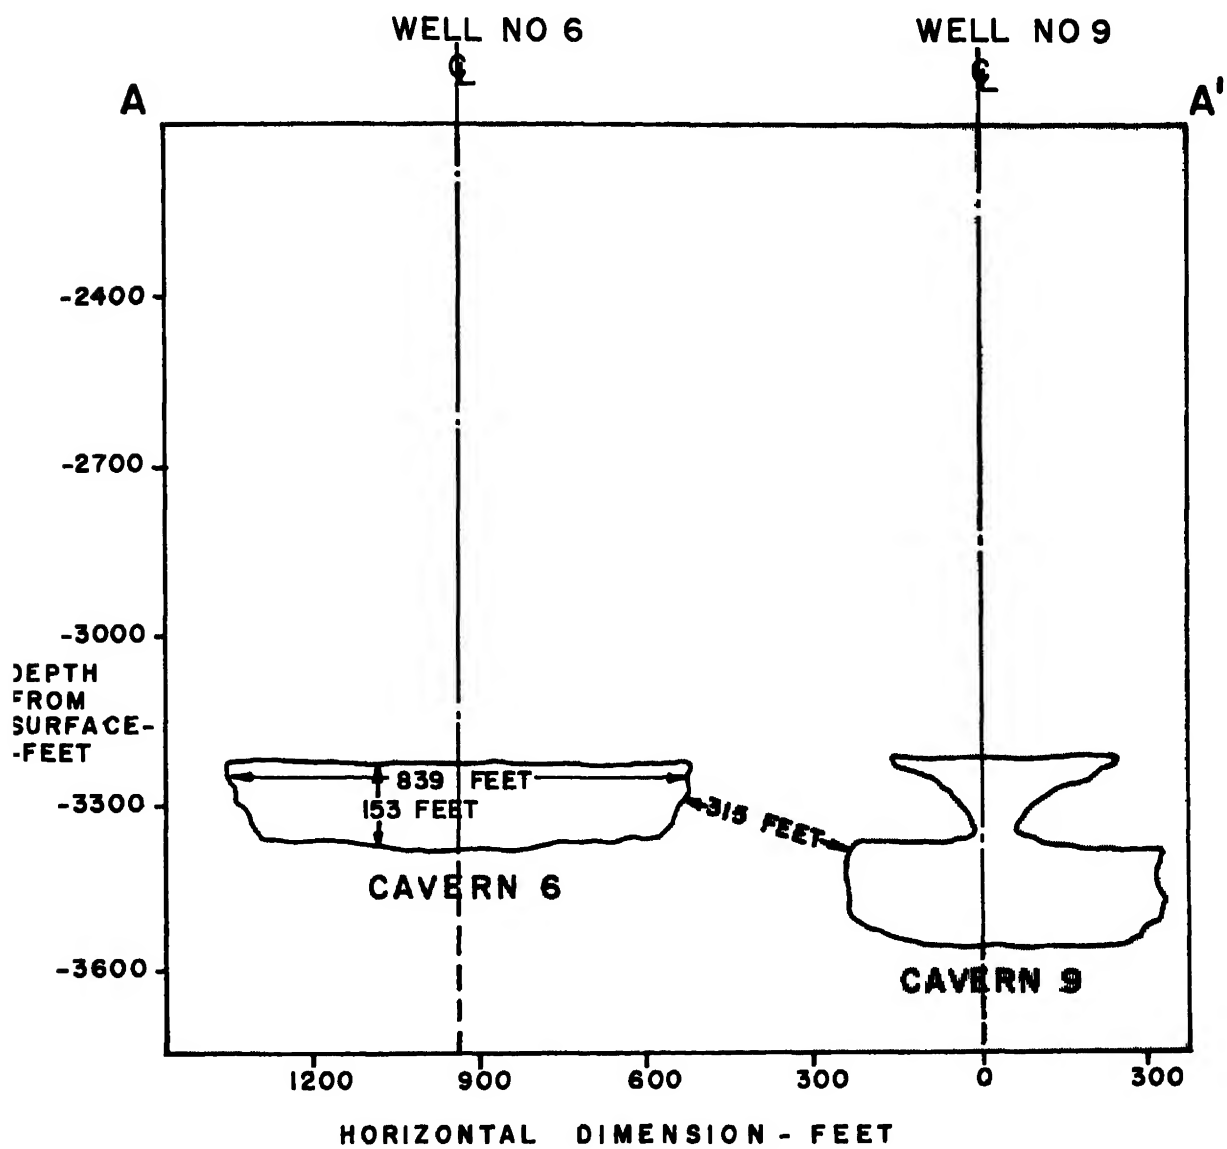
Figure 4b. Cavern 6 Cross Section

The surface and subsurface details of Cavern 6 are shown in Figures 4a and 4b, respectively. At the time of the accident, Cavern 6 contained about 7 MMB of oil and had a fill schedule of 11.9 MMB under the Interim Fill Program.

When Cavern 6 was originally created for solution mining, a 16-inch surface casing was set at 1,640 feet and cemented to the surface. A 24-inch conductor casing was installed at a depth of 87 feet. A 12-3/4-inch casing was set to 2,632 feet and cemented to the surface. When Cavern 6 was adapted for oil storage, a 9-5/8-inch

casing was set at 2,603 feet inside the original 12-3/4-inch casing and cemented back to the surface. The new 9-5/8-inch casing was then pressure-tested to 1,000 psig before drilling out the cement plug at the bottom of the casing. After the plug was drilled out of the casing, the cavern was hydrostatically tested to 715 psig at the surface. Assuming a specific gravity of crude oil of 0.802 (892 psig for a 2,603-foot oil column) the maximum operating pressure at the casing seat is 1,607 psig.

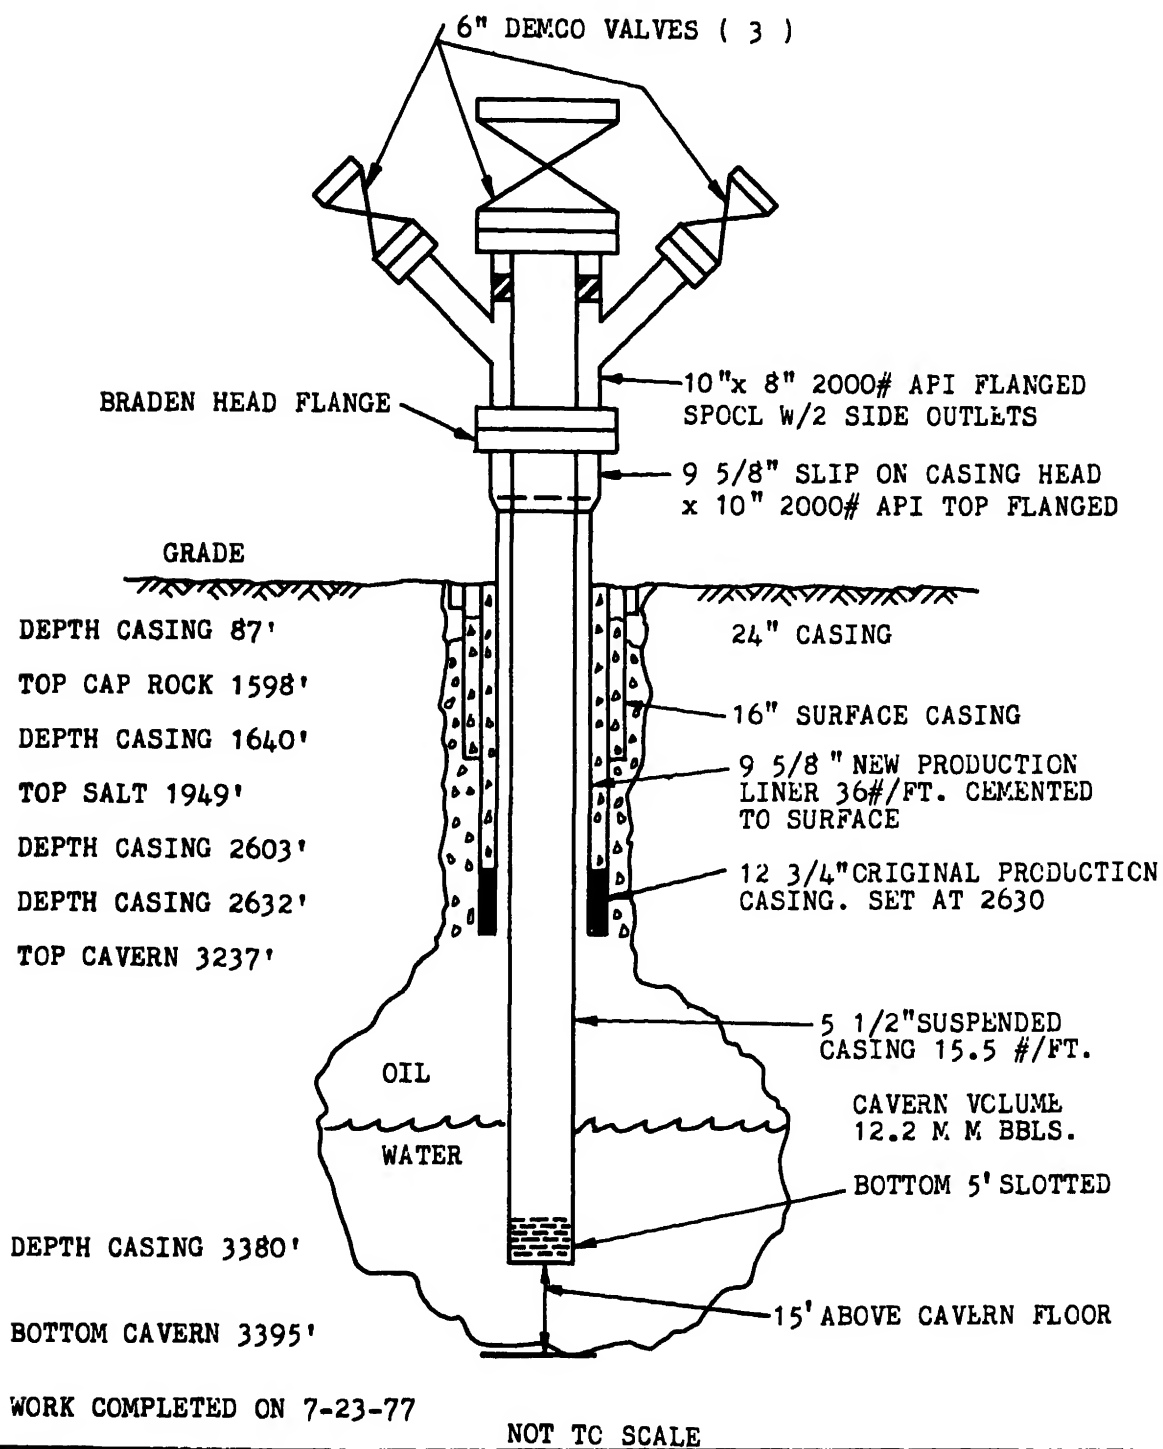
Figure 5. Overall Configuration of Well 6

Figure 5 shows the subsurface configuration of Well 6, as described in Reference 3.

The overall configuration of Well 6 is shown in Figure 5. The procedure called for making Well 6 a "slick hole" (removal of the 5-1/2-inch casing) and for repair of the well head, which had leaked previously.

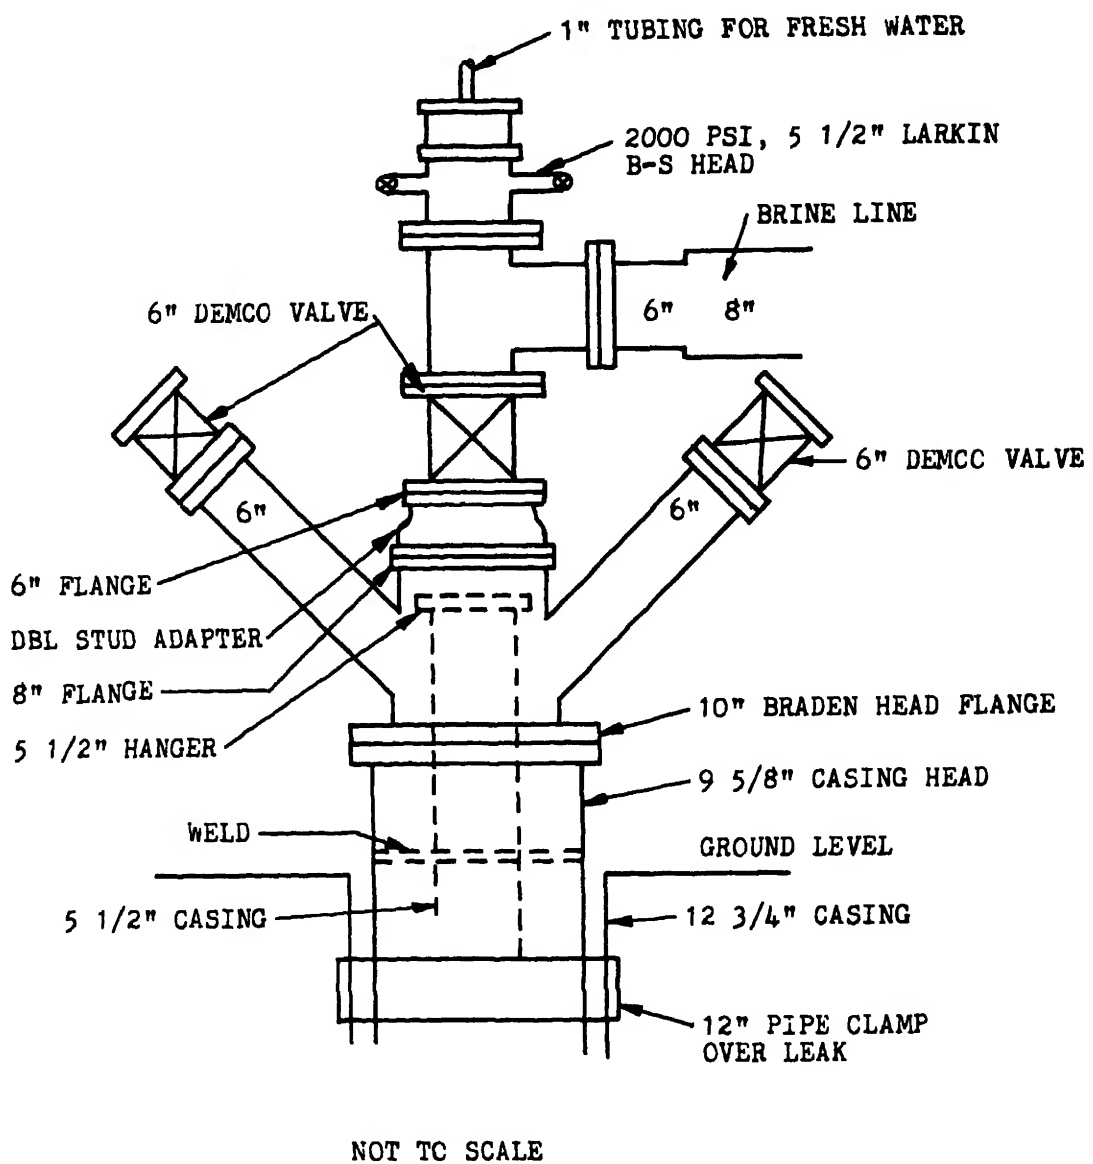
Figure 6a. Well 6 Well Head Configuration Before Workover

Figure 6a shows the configuration of the well head before workover started with piping for brine removal, a 2,000 psi Larkin Head, and 1-inch tubing for fresh water.

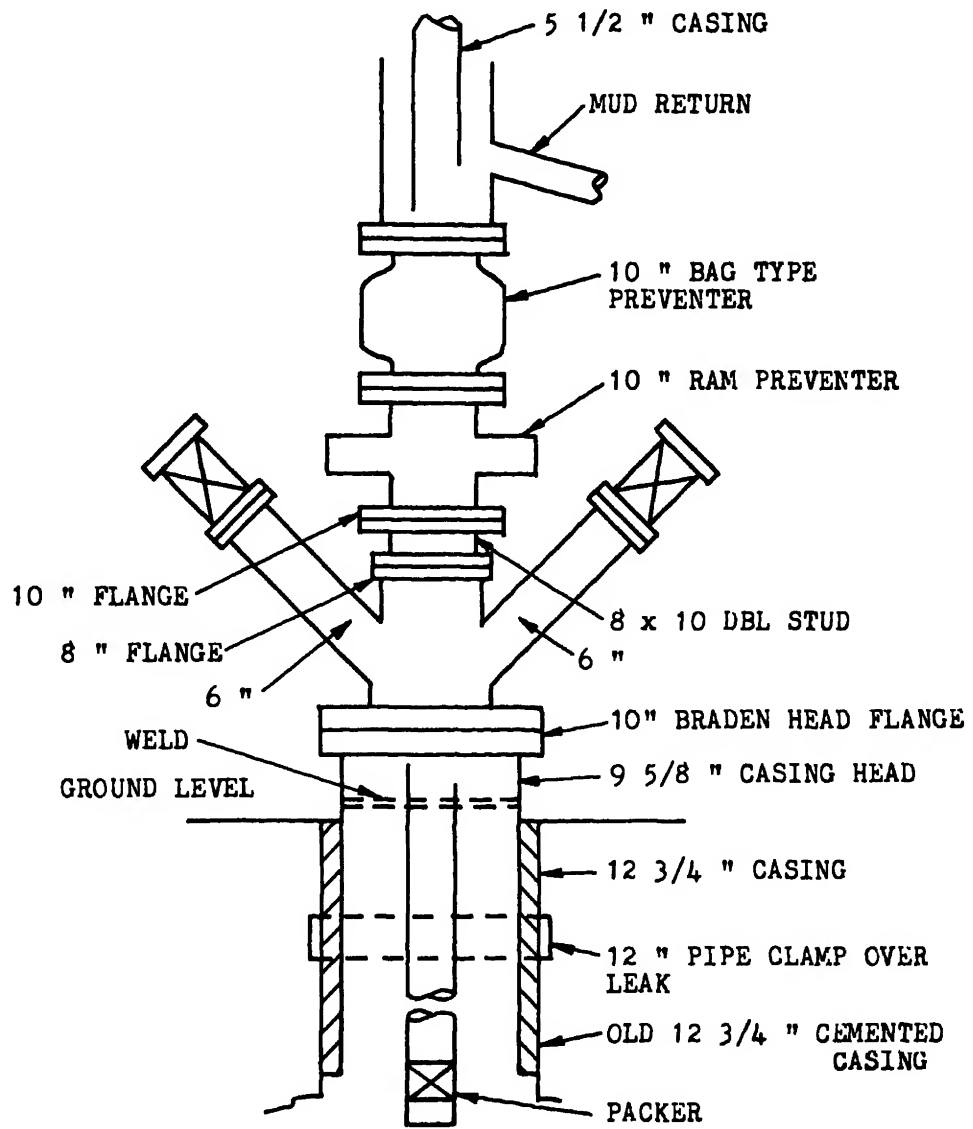
Figure 6b. Well 6 Configuration at Time of Blowout

Figure 6b shows Well 6 at the time of the blowout with a bag-type blowout preventer, a ram preventer, the mud return line, and packer.

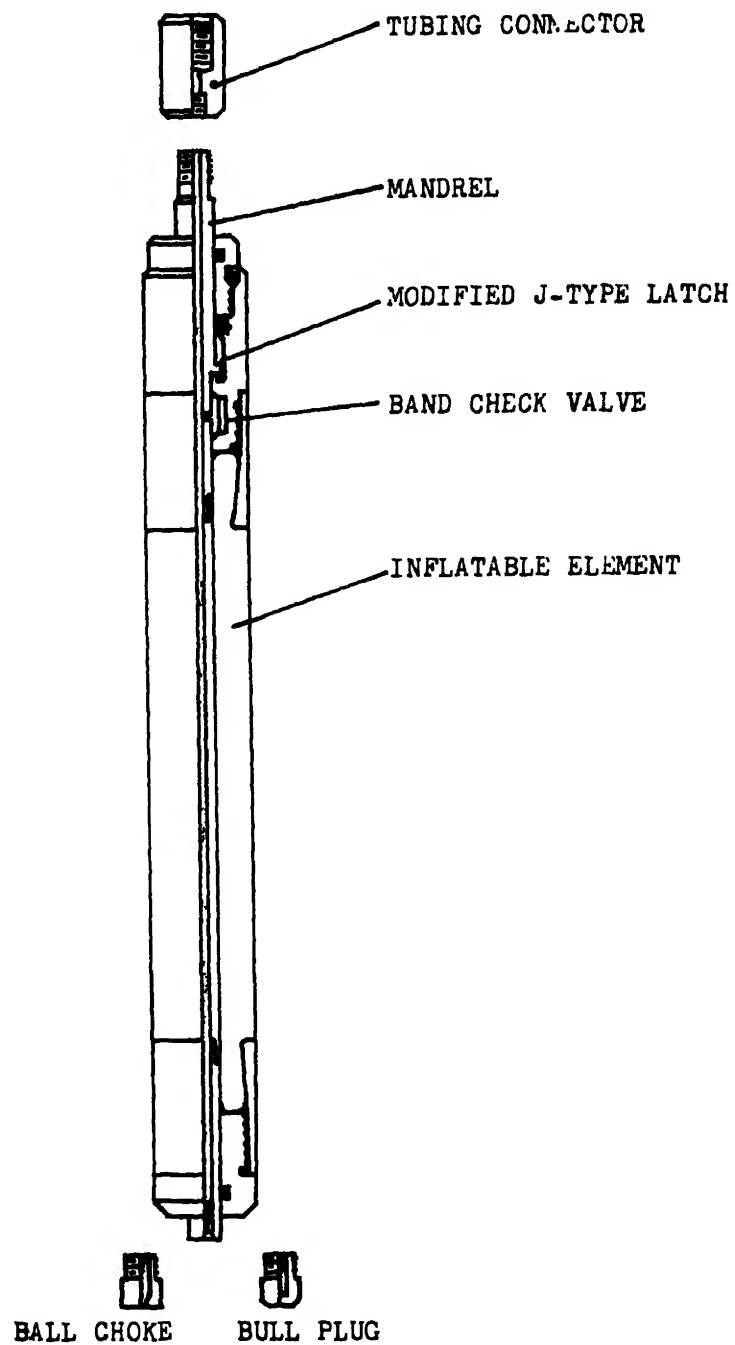
Figure 7. TAM Set Inflatable/Retrievable Packer

Figure 7 shows the TAM Set Inflatable/Retrievable Packer. The inflatable element is normally inflated by water pressure to 500 psi at the setting depth to conform to the hole and then increased slowly to about 2,000 psi to fully set the packer and shear the setting ball through the choke, opening the mandrel for fluid flow. The packer can be deflated by a quarter turn to the left (positive stop) to release the modified J-type latch which allows the mandrel to move upward. The water then flows back into the mandrel and the packer deflates for retrieval or relocation.

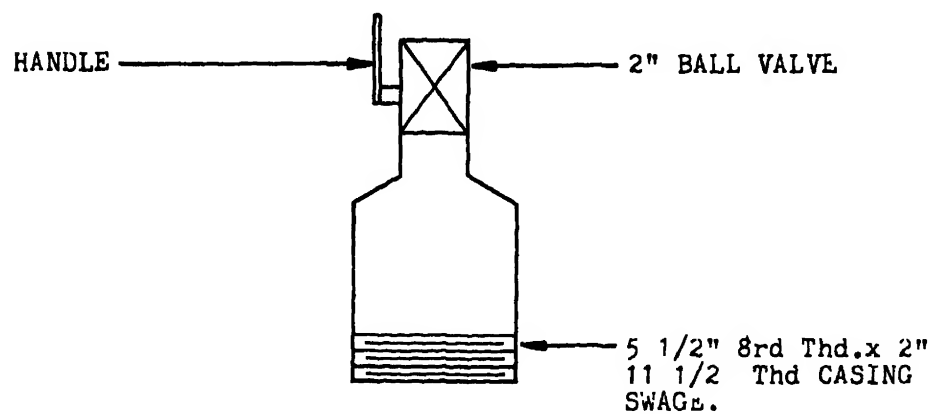
Figure 8. Safety Valve for Use as Stabbing Valve as Made up for Well 6

Figure 8 shows the safety valve used on the rig at the time of the accident. The device consists of a 5-1/2-inch by 2-inch casing swage with a 2-inch ball valve. To be utilized as a safety valve, it must be screwed into the top of the 5-1/2-inch casing to control the flow of fluids.

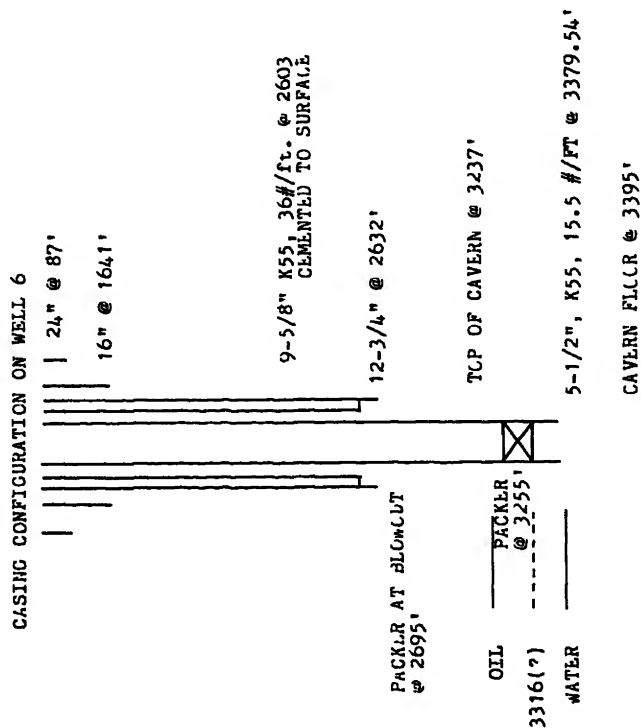
Figure 28. Initial Hydraulic Forces on the Packer

The analysis of the well bore conditions when the packer was set, before the tubing was pulled out of the hole, is shown in Figure 28. The U-tube representation of the hole shows that

U TUBE ANALYSIS

THE CONDITIONS IN WELL 6 CAN BE REPRESENTED AS A "U" TUBE FOR THE PURPOSE OF ILLUSTRATING THE HYDRAULIC PRESSURES ON THE TAM PACKER.

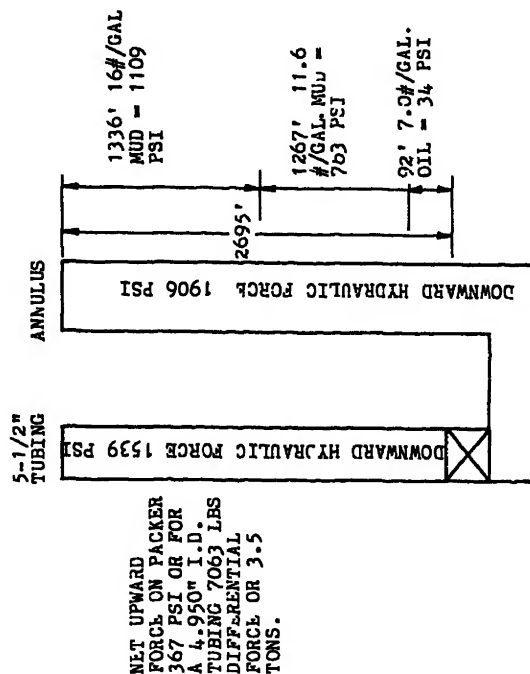
Figure 29. Hydraulic Forces When the Packer Failed

upward force when it had been previously set, it is assumed that the 7,063-pound total differential force exerted beneath the packer at that point in time, shown in Figure 29, caused the packer to slip up the hole and ultimately to be ejected from it.

Judging from the available data and testimony, it is evident that the packer failed because of a poor packer seat in the 5-1/2-inch casing due probably to salt or scale. It is unlikely that any design failure occurred with the TAM packer.

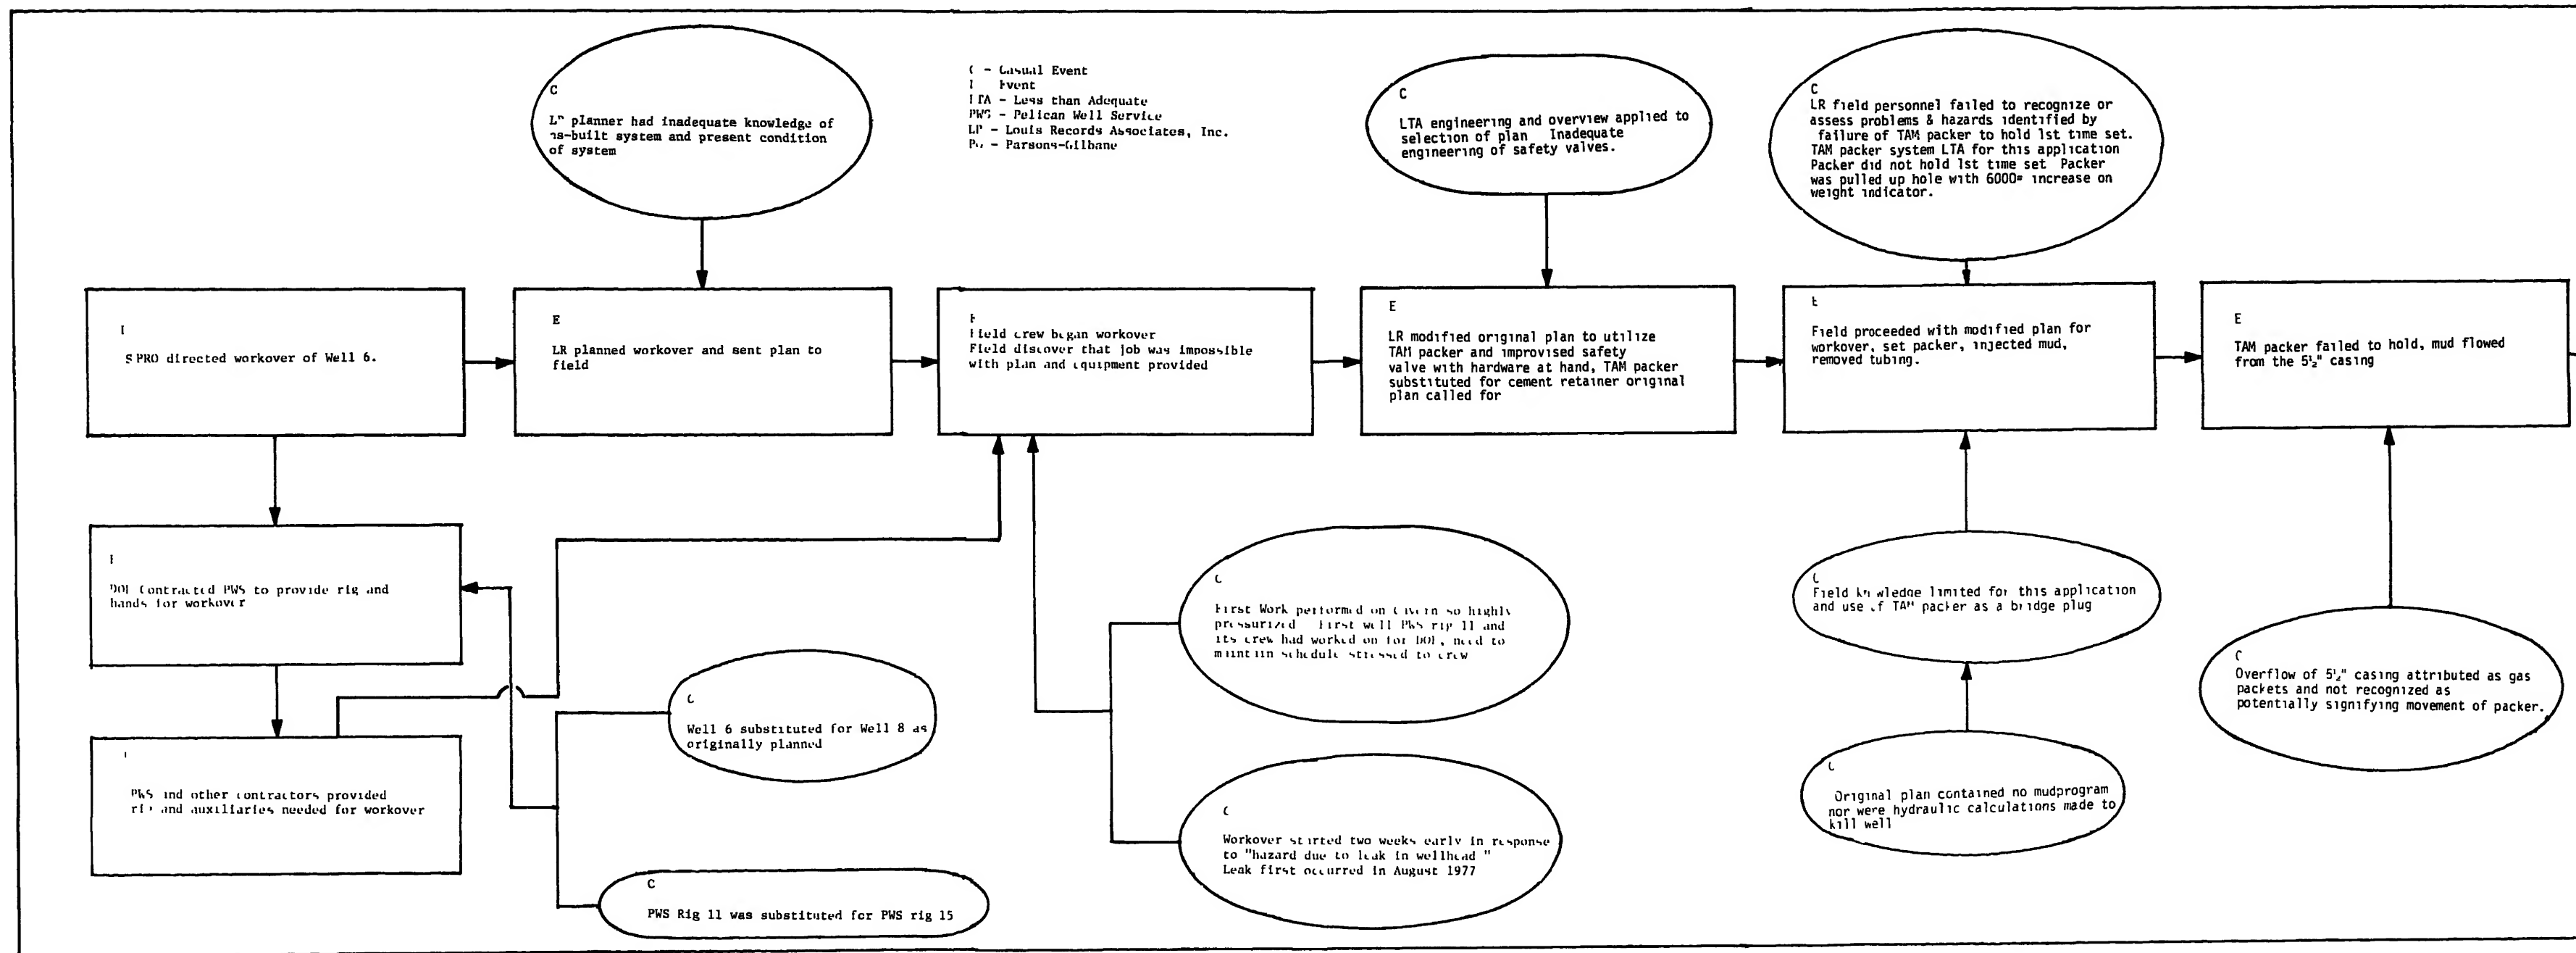
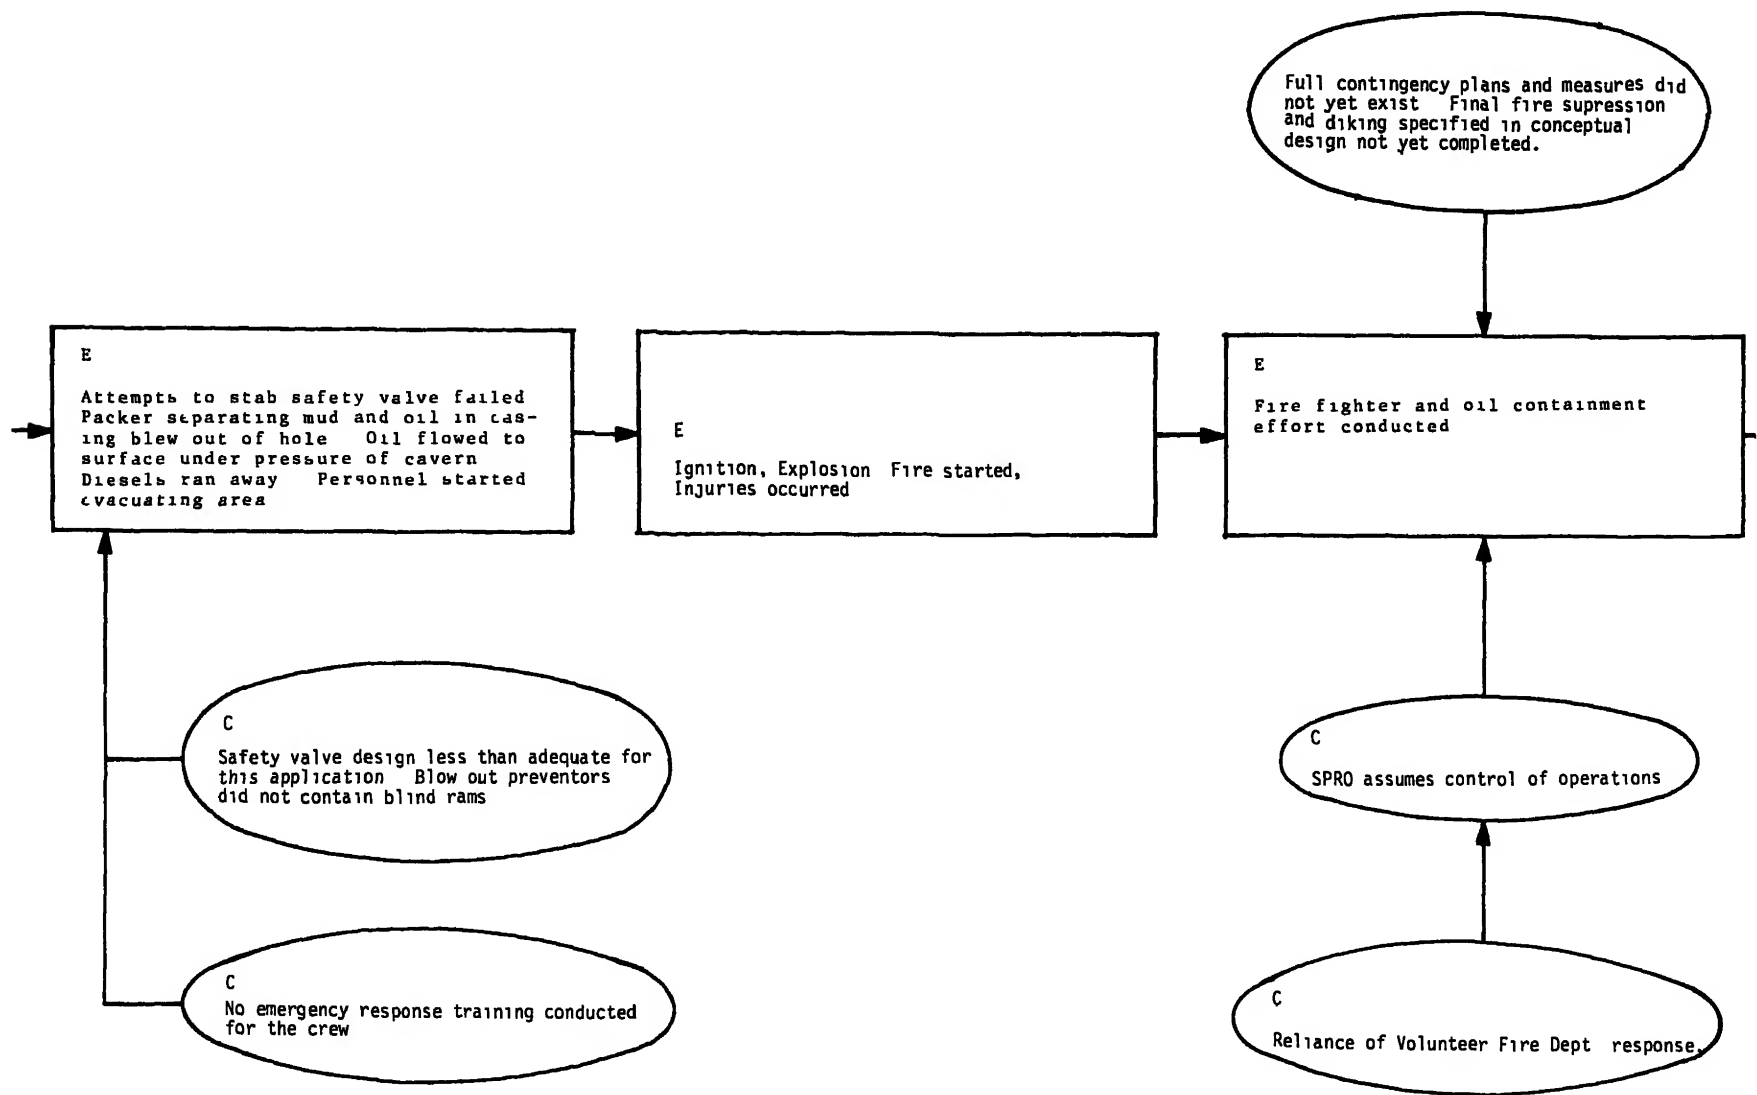
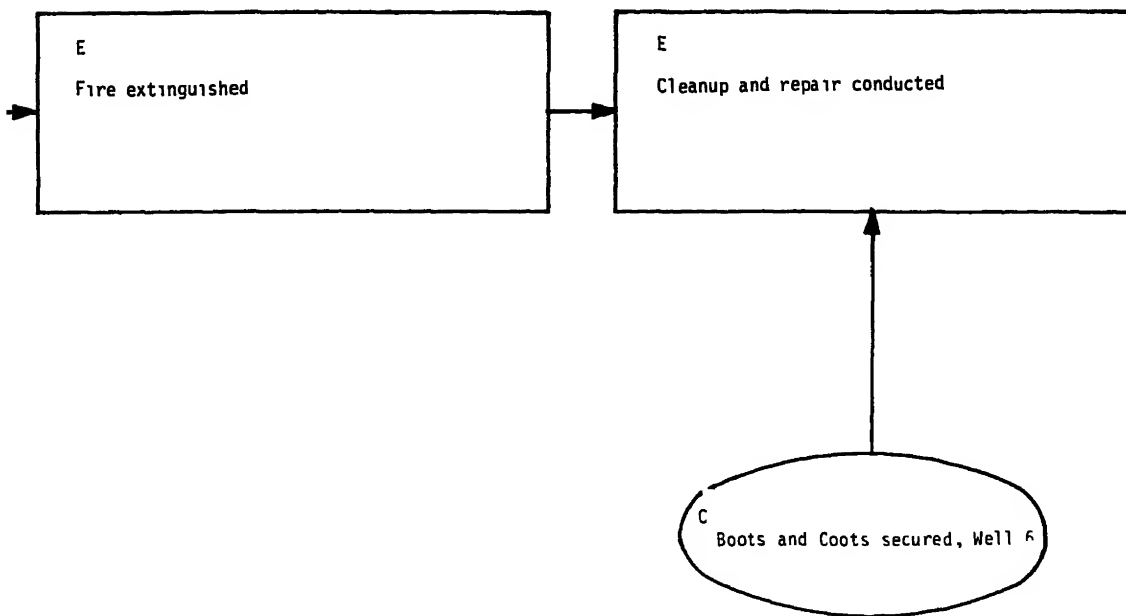
Figure 30. Analysis of Workover Operations (Events Sequence Chart)

There are a number of key management activities and decisions that contributed to developing the events surrounding the accident. This section of the report is divided into two major subsections: (1) a description of 11 key events; and (2) the management actions relative to those events. Figure 30 shows the relationships between these events. Attachment I gives a much more detailed representation. The analysis in this section goes up to the beginning of the fire ($T = 0$). The next section of the report carries the discussion on through the emergency response period ($T = 0$).

- (3) The Pelican Well Service field crew began to execute the workover procedures and discovered they could not perform the job according to the procedures because of the well hardware conditions encountered and the equipment available.

- (4) Louis Records' main office and field management participated in developing a modified plan using a TAM packer. No other safety backup was utilized except for a manually controlled safety valve improvised at the site.

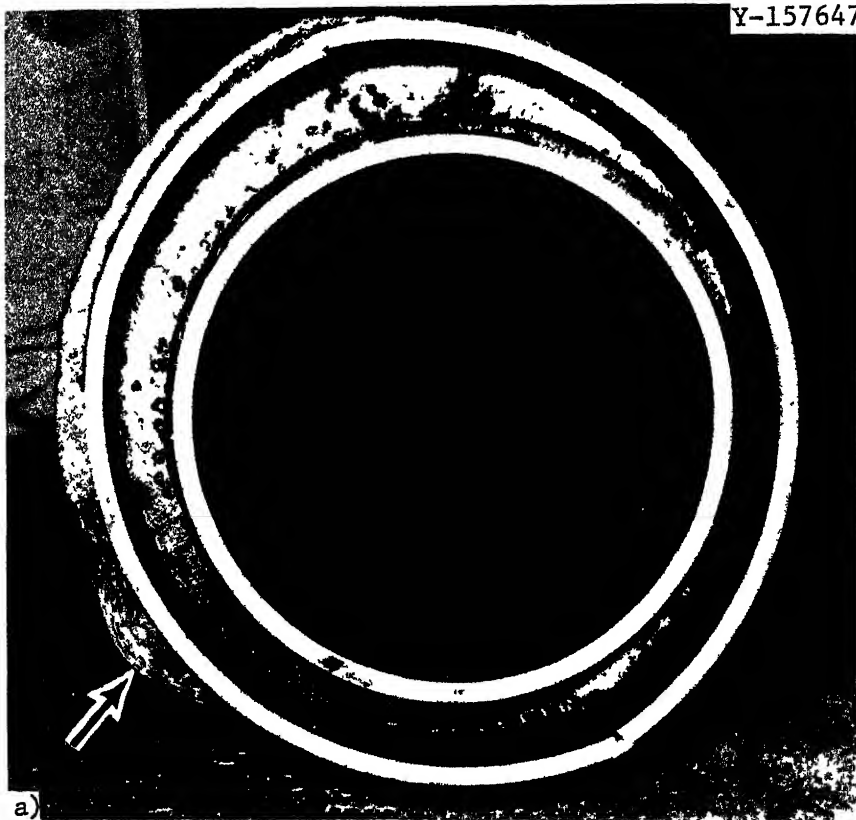
A flame-cut spacer which had been welded between the heavy walled wellhead and the thinner walled outer casing is shown in Fig. 8. Photographs showing end and side views of one of the dissected segments revealed this ring spacer. The welds making this attachment of the spacer are identified as Welds C and D (Fig. 3). Dye-penetrant inspection of the inner weld (Weld B, Fig. 3) which attaches the 0.24-m-diam (9 5/8-in.) pipe to the heavy pipe section of the wellhead revealed severe cracking and a through-leak. A longitudinal view of the area containing Welds

Fig. 8. Two Views of Section of Wellhead Assembly Containing Flame Cut Spacer Ring (Arrows) Which had been Welded Between the Heavy Walled Wellhead and Outer Casing (see Fig. 3, Welds C and D).

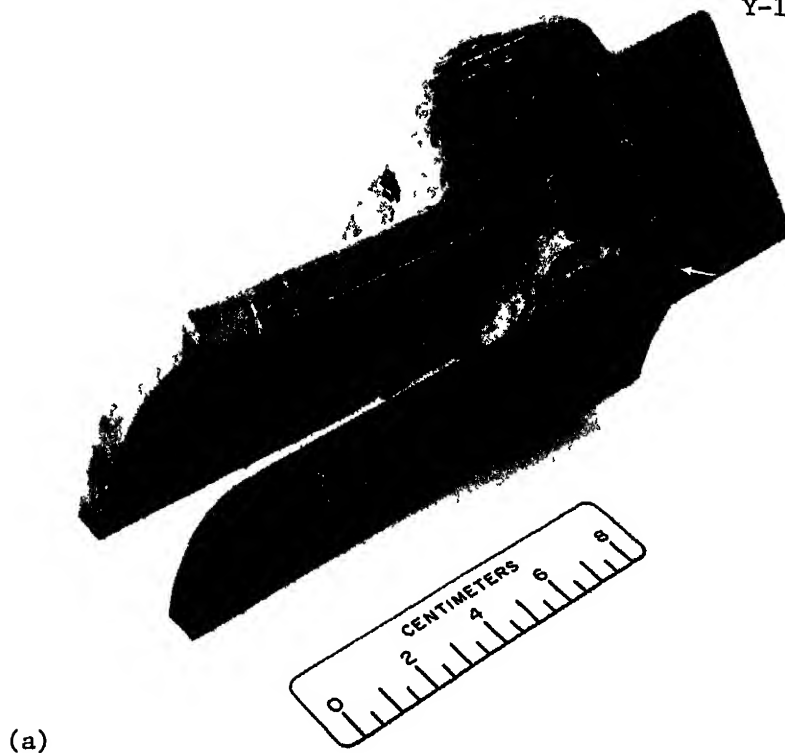
B, C and D can be seen in the photographs shown in Fig. 9. Likewise, a through-leak was found in a longitudinal weld in the outer casing (Figs. 10 and 11) which were located under the clamp-type patch. This longitudinal weld is identified as Weld E (Fig. 3). Thus, a potential leak path for petroleum was found leading from the inside of the 0.24-m-diam (9 5/8-in.) pipe through the internal bore weld (Weld A, Fig. 3) into the annulus between the inner and outer casing, through the weld (Weld B, Fig. 3) at the end of the annulus and to the outside through the longitudinal weld of the outer casing.

Fig. 9. (a) Longitudinal Views of Cuts Made Through Welds B, C and D (Fig. 3). Reduced 6%. (b) Dye-penetrant tests pointed out these locations as through-leaks. Reduced 11%. Note the complete fracture of weld B indicated by arrow.

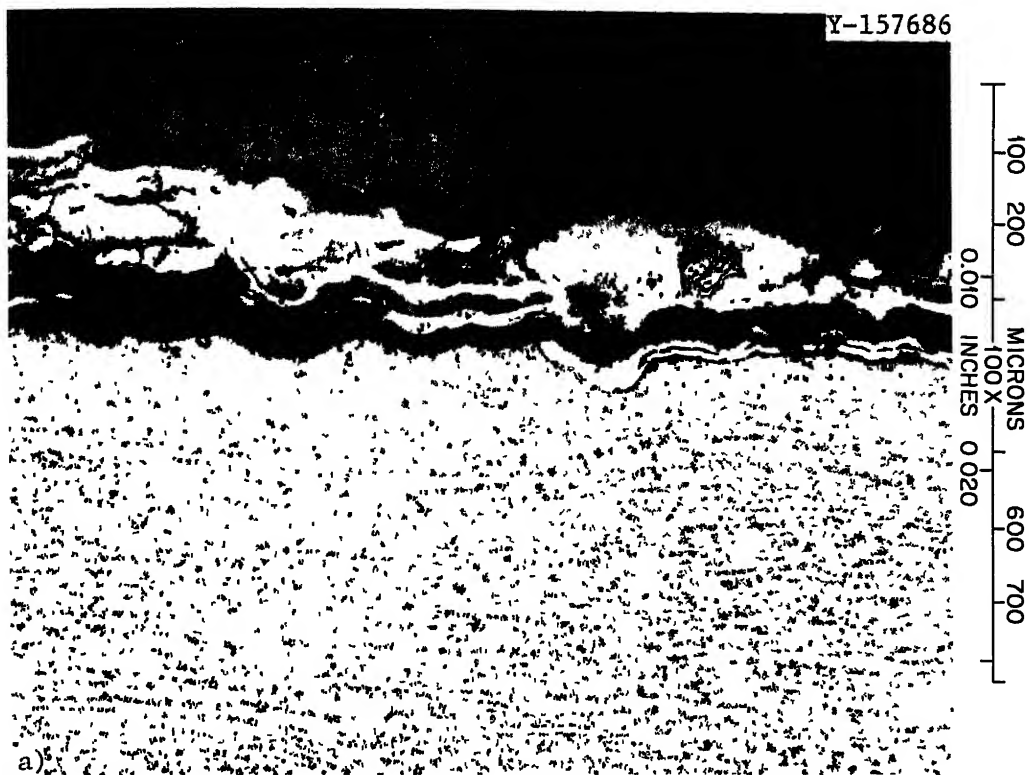
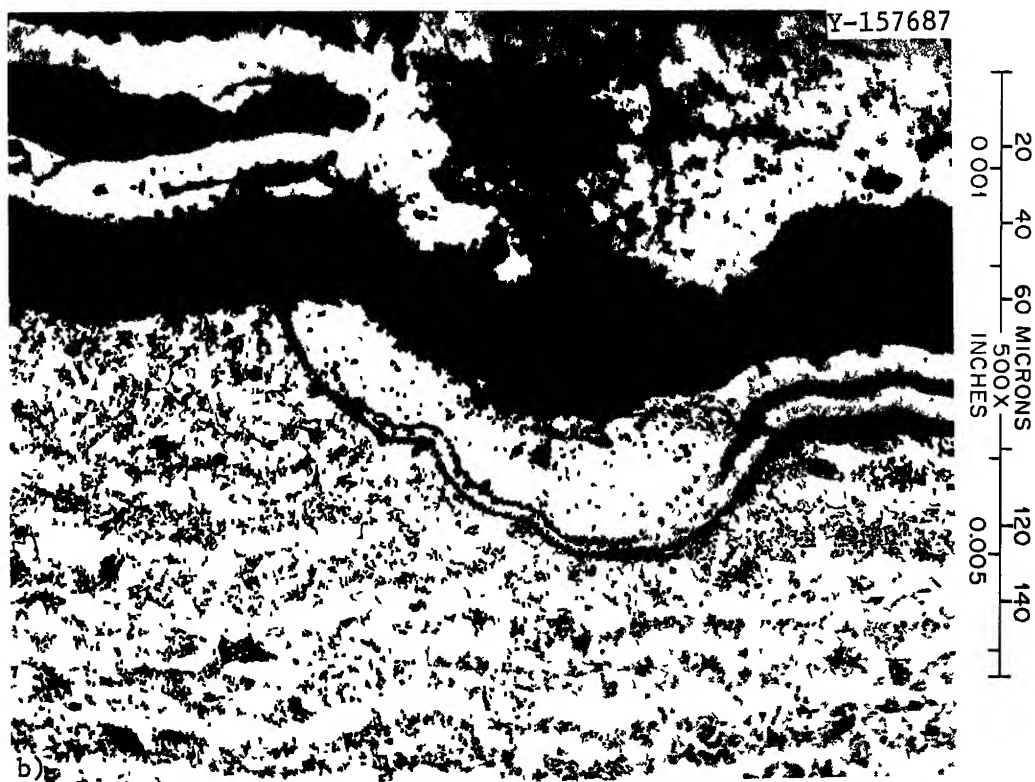
The pipe designated as Pipe 14 was dissected by sawing to facilitate metallographic examination and is shown in Fig. 15. A section of this pipe is shown in Fig. 16. The microstructure is shown in Fig. 17; although some scale is evident on the inside surface, the wall is essentially undamaged.

Fig. 17. Microstructure of Pipe 14. Photomicrograph was made at exterior surface. Some oxidation can be seen, but the wall is essentially undamaged.

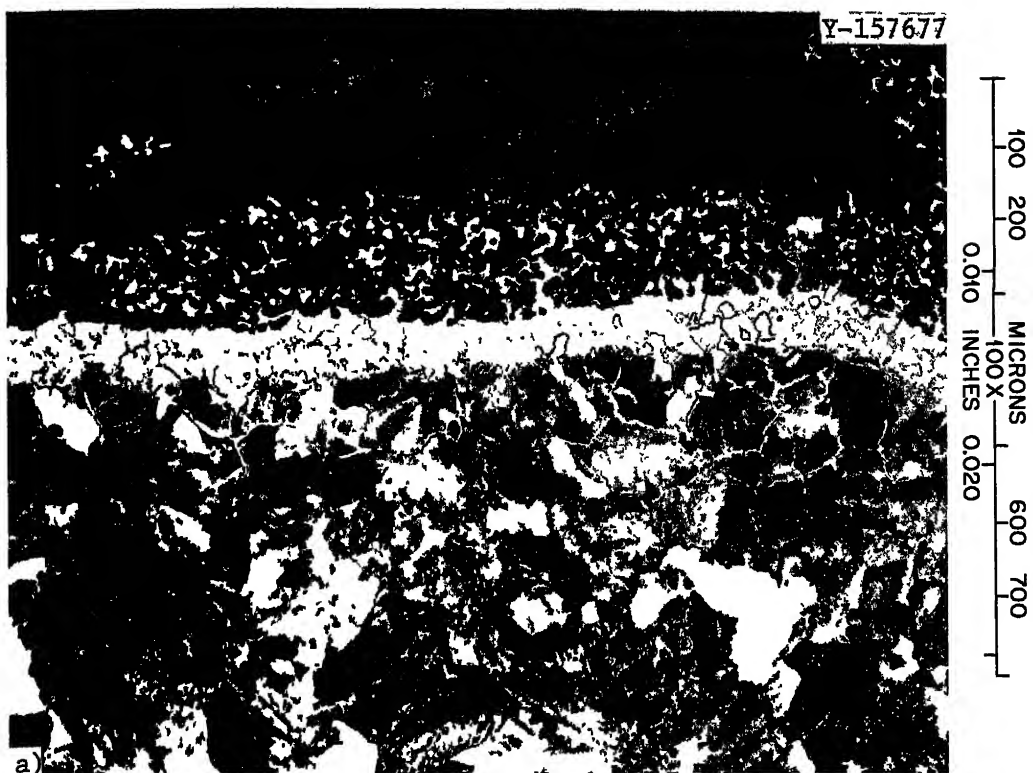
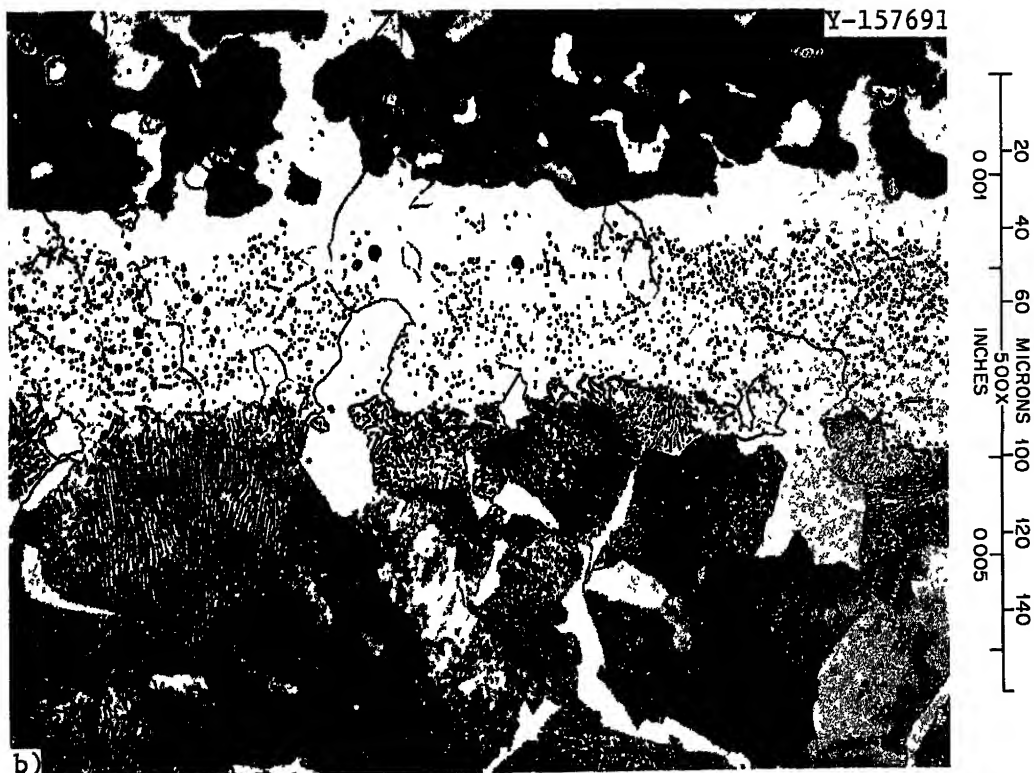
A typical pipe of this type designated as Pipe 2, was dissected to permit further examination and is shown in Fig. 18. The extensive amount of loosely adherent internal scale (powder) is evident in Fig. 19. Considerable variation in the wall thickness can be seen in Fig. 20. Typical microstructures of Pipe 2 is shown in Fig. 21. The black loosely-adherent powder reaction product found in Pipe 2 was extremely light weight and contained sufficient magnetic material in it to be attracted by a magnet. Although x-ray diffraction showed the metallic oxide to be primarily Fe_2O_3 , undoubtedly some magnetic Fe_3O_4 and/or metallic Fe was present. Approximate chemical analysis of the powder showed 40% Fe, 17% C, and 600 ppm Cl.

Fig. 21. Microstructure of Pipe 2. Note the carburized condition of the microstructure as compared with Pipe 14 (Fig. 17). A decarburized layer at the inner surface of the pipe wall near a reaction product can be seen.

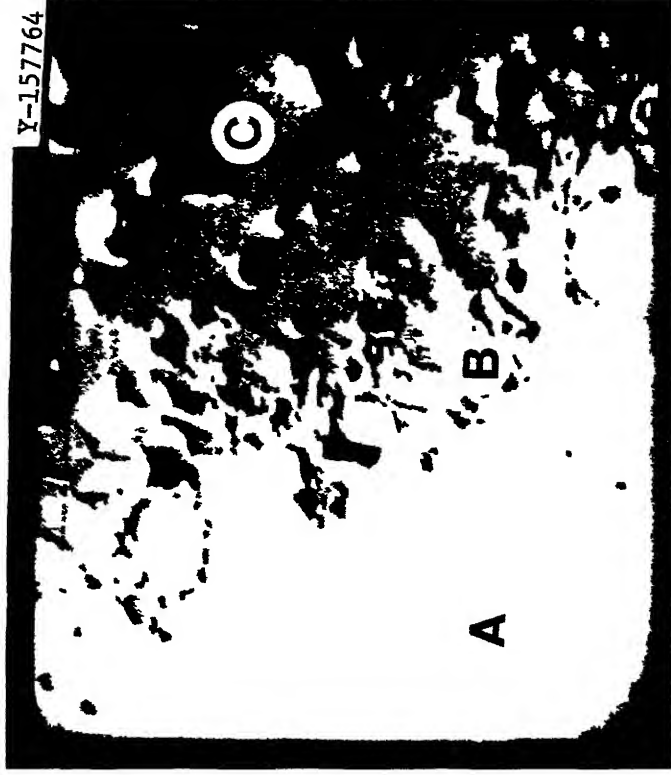
Fig. 27. Backscattered Electron Image of Scale-Metal Interface. A, B and C indicate locations from which x-ray spectra were taken.

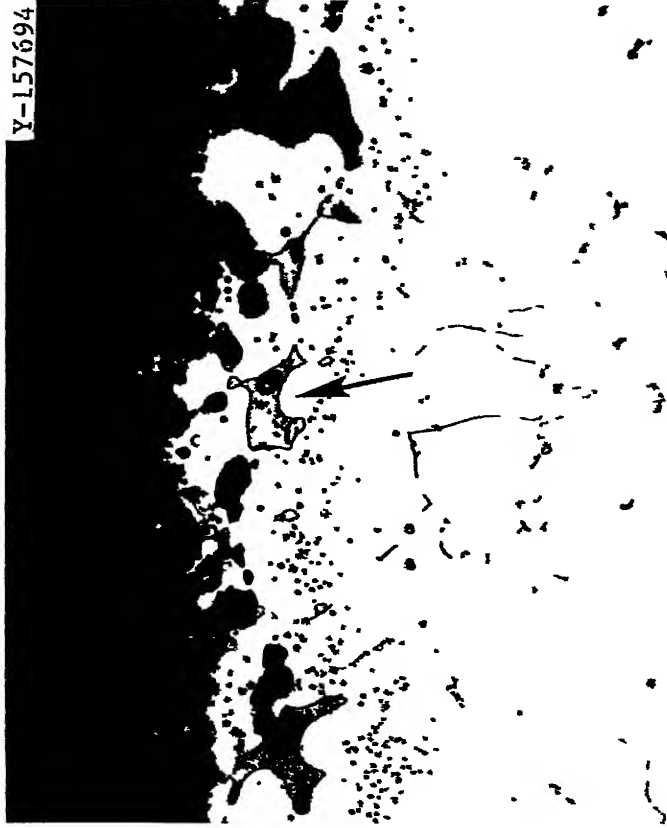
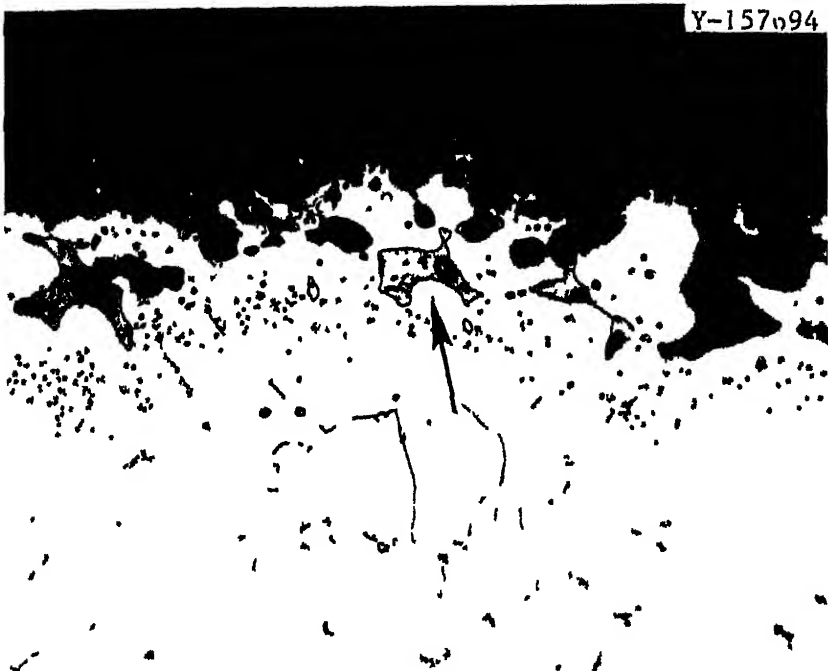
A eutectic composition was evident in the underlying base metal of a section of pipe shown previously in Figs. 22, 23 and 24. This eutectic condition in the microstructure of Pipe 3 is shown in Fig. 26. This condition was evident in all sections of pipe showing considerable reduction of the wall.

Fig. 26. Pipe 3, Eutectic Structure (arrow) in the Base Metal Near the Deposit. 500x

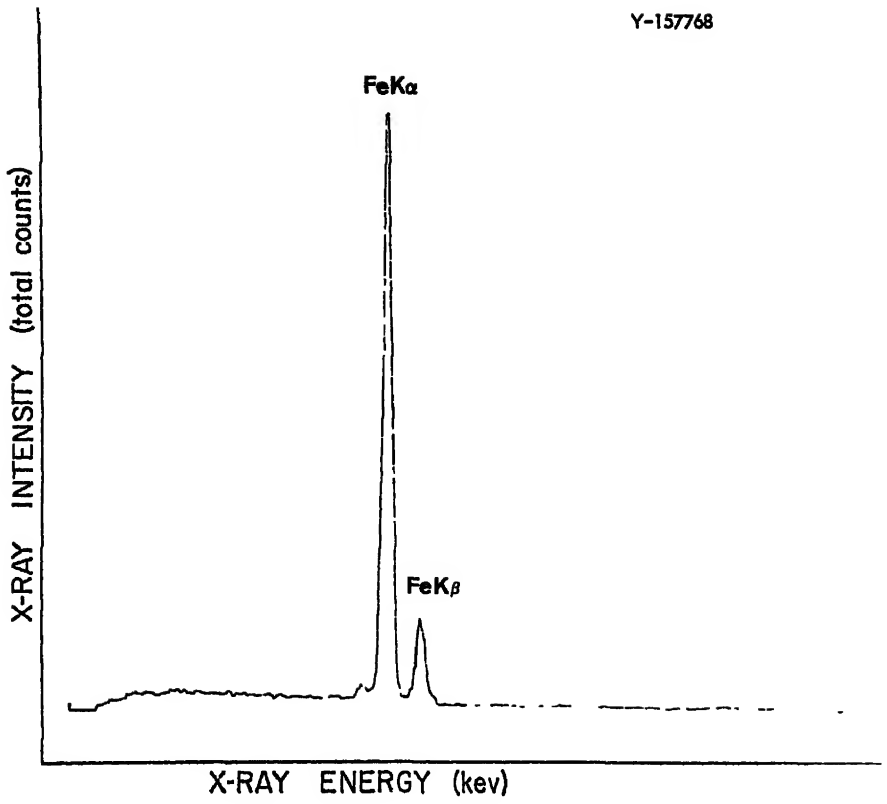
Fig. 28. Pipe 3 Wall (Area A, See Fig. 27).

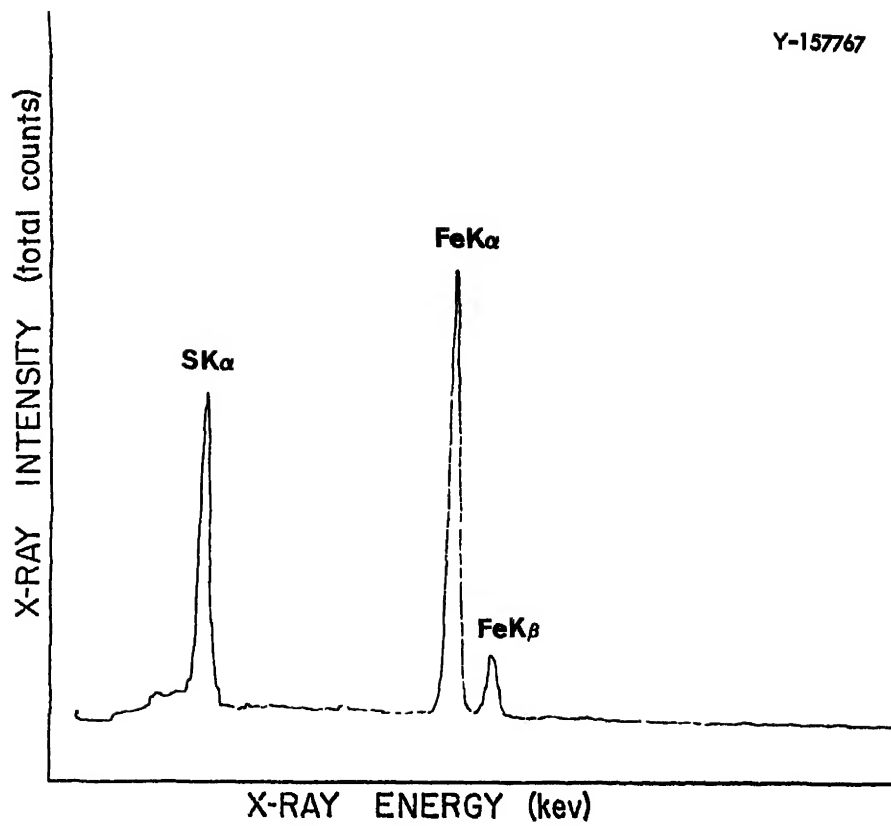
Fig. 29. Pipe 3 Eutectic Composition (Area B, See Fig. 27).
